TECHNICAL PAPER

Qualification of Surface Preparation Processes for Bonded Aircraft Repair

Giles Dillingham Ph.D., Chief Scientist

Brighton Science

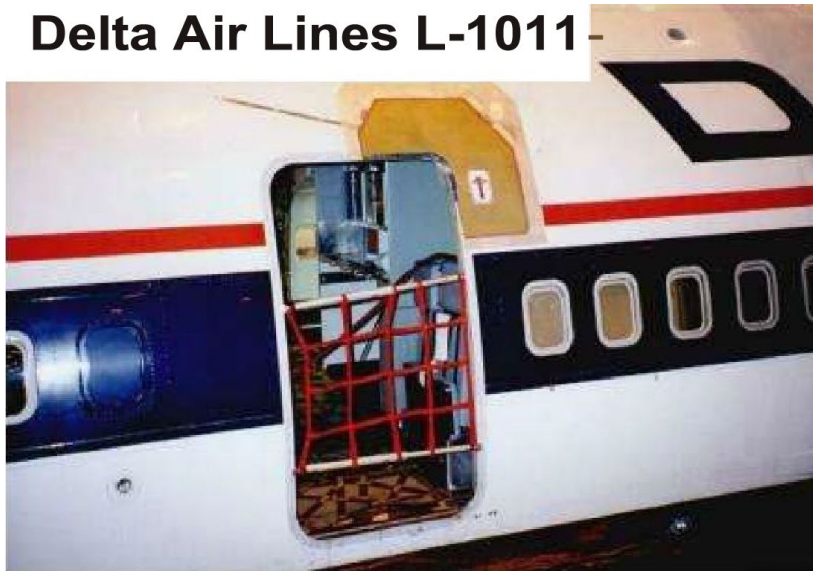
Figure 1: Bonded boron/epoxy composite doubler for repair of aluminum aircraft [1].

Figure 1 shows an example repair that involved bonding a composite patch onto an aluminum aircraft skin. A major concern with any bonded repair are disbonds that can occur at installation of the doubler or at anytime during the service life of the aircraft [1, 2].

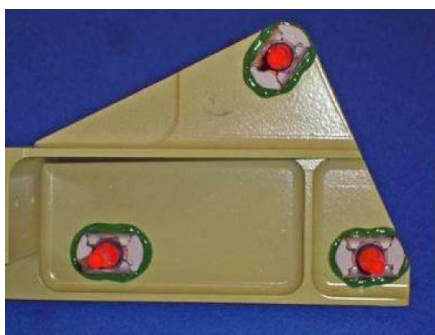
Figure 3: Nutplates bonded to an aluminum casting. Orange elastomer tabs passing through threaded fastener are for fixturing during adhesive cure and are removed prior to use.

An example of bonded repairs is the replacement of captive threaded fasteners (nutplates) that are adhesively bonded to an airframe to allow installation and removal of components and panels for maintenance and repair. Figure 3 shows typical bonded nutplates on a segment of an aerospace structure.
